Manhole Inspection Summary

Manhole # S39MM_039MH

Insp Date: **4/3/07 1:24 PM**

Location Address: **2000 OAK HILL AVE**

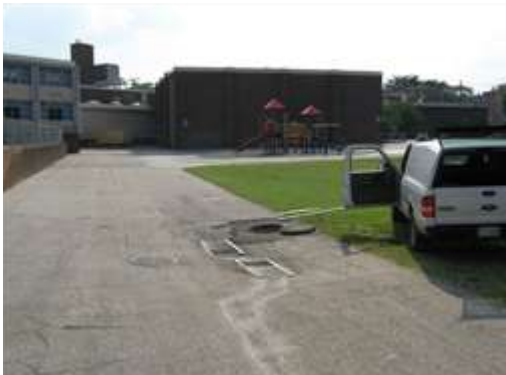
Location View

Behind 2000 Oakhill Ave Elementary School

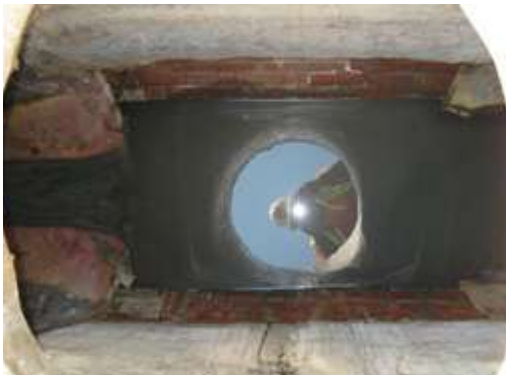
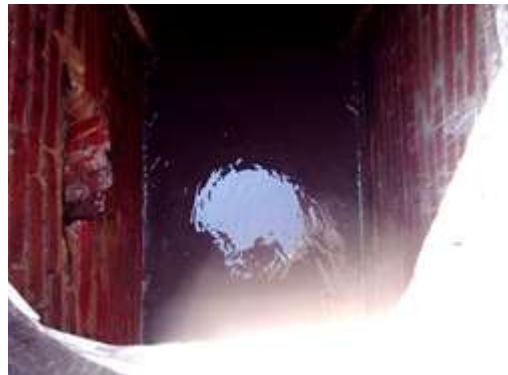
Top View

Condition: ☐ Sound ☐ Cracked ☒ **Leaks**

Infiltration: ☐ None ☒ **Joint** ☐ Cracks ☐ Mortar ☐ Roots ☒ **Wall**

Infiltration: ☐ None ☐ Joint ☐ Cracks ☐ Mortar ☐ Roots ☒ **Wall**

Frame leaks. Adjustment and Barrel infiltration.

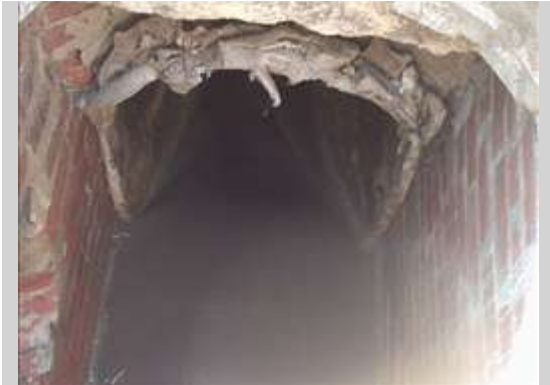
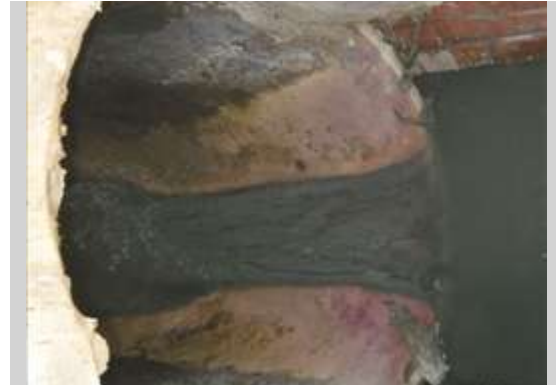
Comments **The O12 is larger than the I6.
04 Sep 08...I9 has a pipe "customized" opening that is larger than 8" but smaller than 9". see pics**

24 in. (w) x 30 in. (h) Rectangle Gravity Sewer
Pipe Out @ 12 O'Clock

Infiltration: **None** Pipe Seal Cond: **Sound**

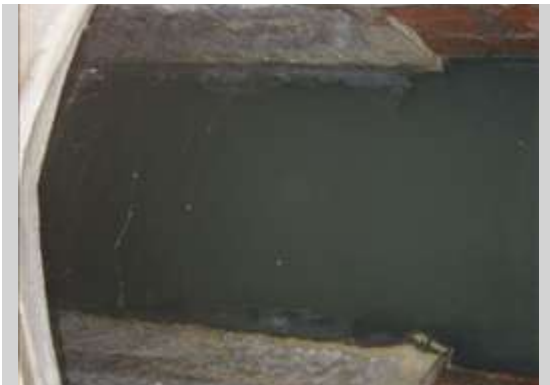
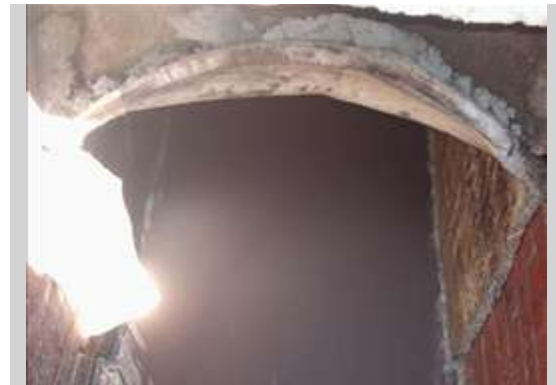
24 in. (w) x 30 in. (h) Rectangle Gravity Sewer
Pipe In @ 6 O'Clock

Infiltration: **None** Pipe Seal Cond: **Sound**

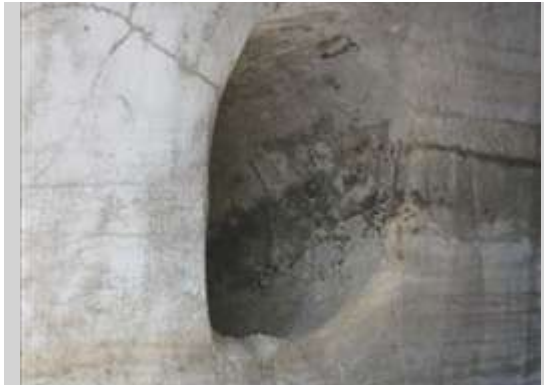
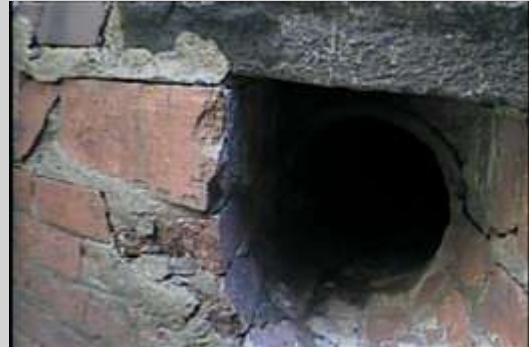
Pipe In @ 9 O'Clock

pipe opening is larger than 8", but smaller than 9"
